THE 1970 LABOR DAY WEEKEND FLOOD
IN THE VICINITY OF UPPER
TONGO CREEK, ARIZONA

U. S. FOREST SERVICE
SOUTHWESTERN REGION
JULY 1971

Report Prepared By: Thomas E. Elson, Forest Hydrologist

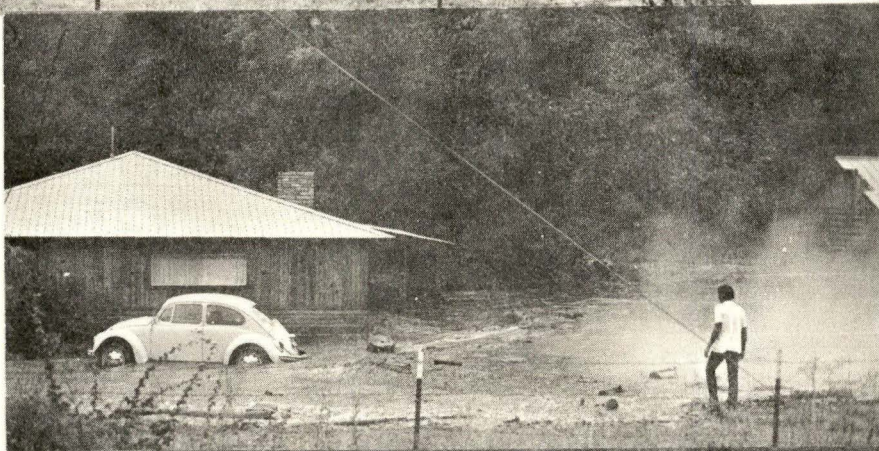
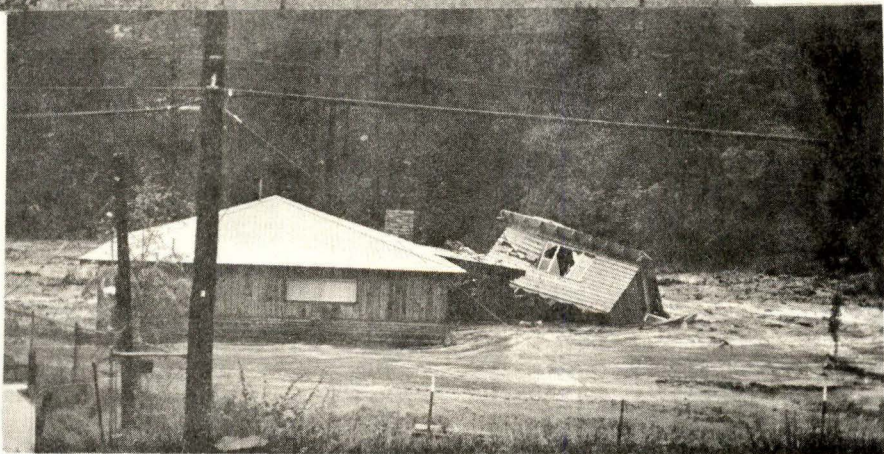
Photo 1 - Sequence of photographs showing a dwelling being swept away by Tonto Creek flood waters on September 5, 1970.

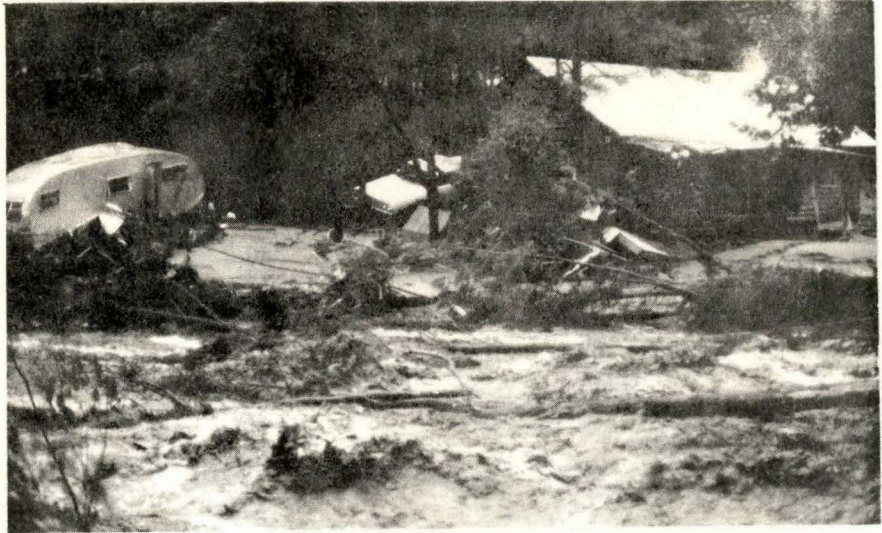
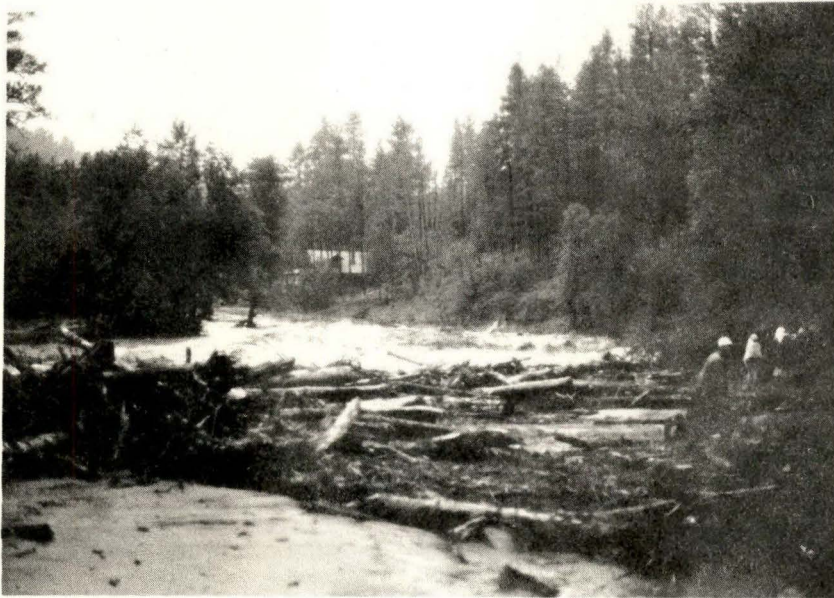
**Photo 2 - Flood flow
in Tonto Creek below
Kohl's Ranch. Observers
saw parts of two summer
homes, two cars and eight
house trailers float by
in the vicinity of where
these photographs were
taken.**

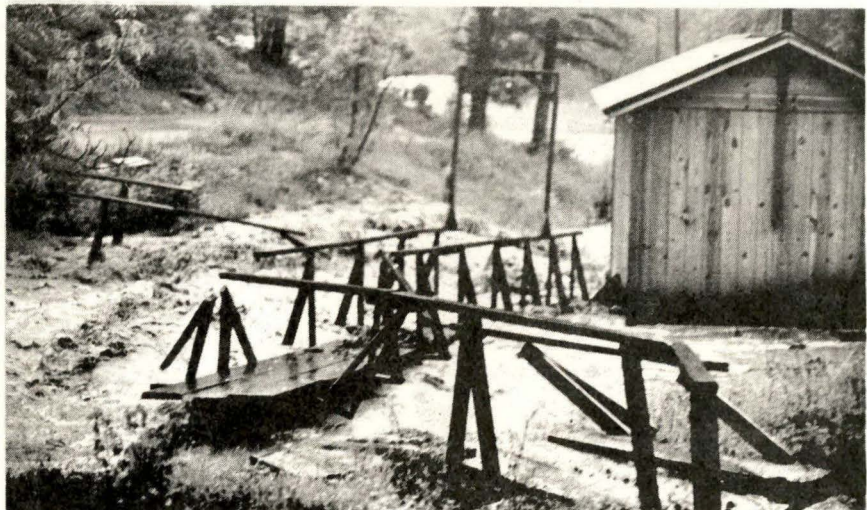
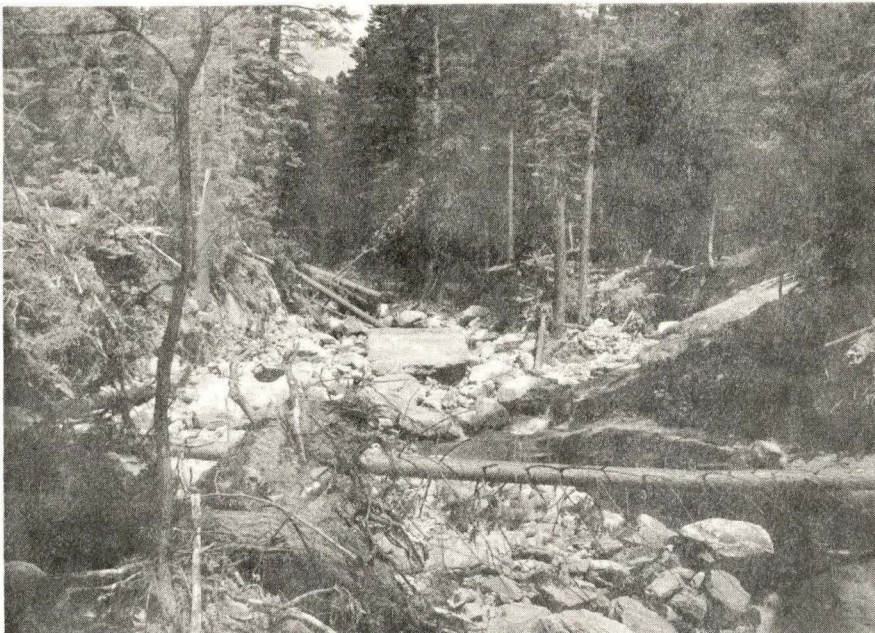
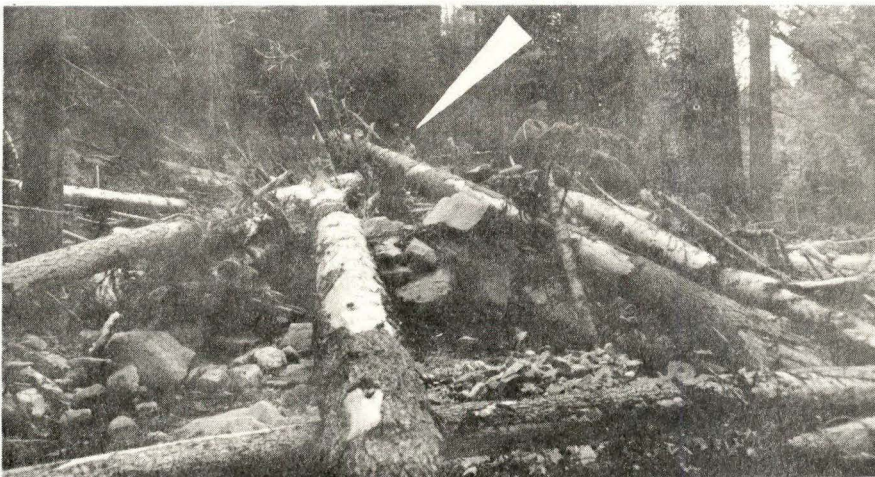
Photo 3 - Over 100 acres of live trees were torn out by the flood waters. Eyewitness accounts indicate that one of the more terrifying aspects of the flood was the noise created by the rolling, bouncing, and colliding boulders. Note men in upper and lower photographs at point of markers.

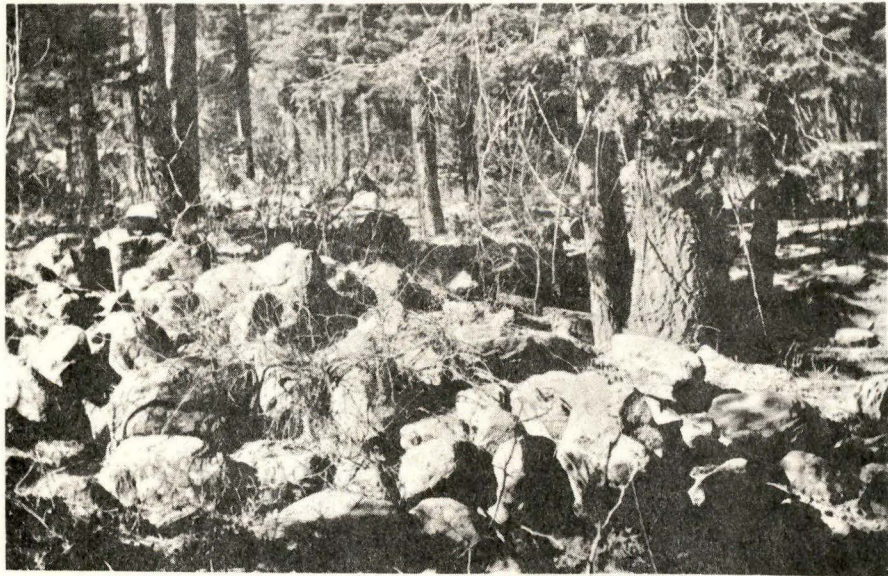
Photo 5 - Close-up view of old flood deposits along Tonto Creek.

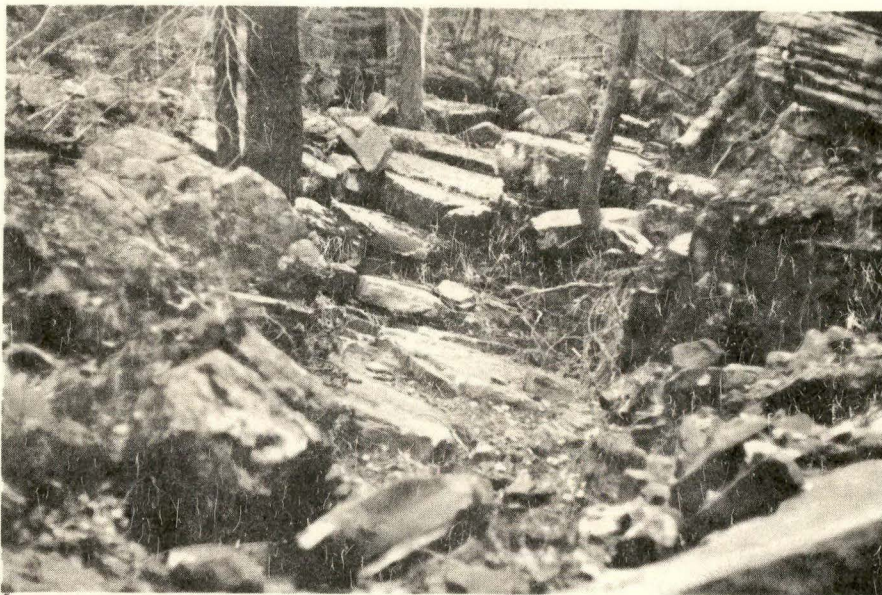
Photo 7 - Above and near the top of the Rim channel flow ran unusually deep, but no severe channel damage was observed in these headwater areas until channel gradients began to steepen.

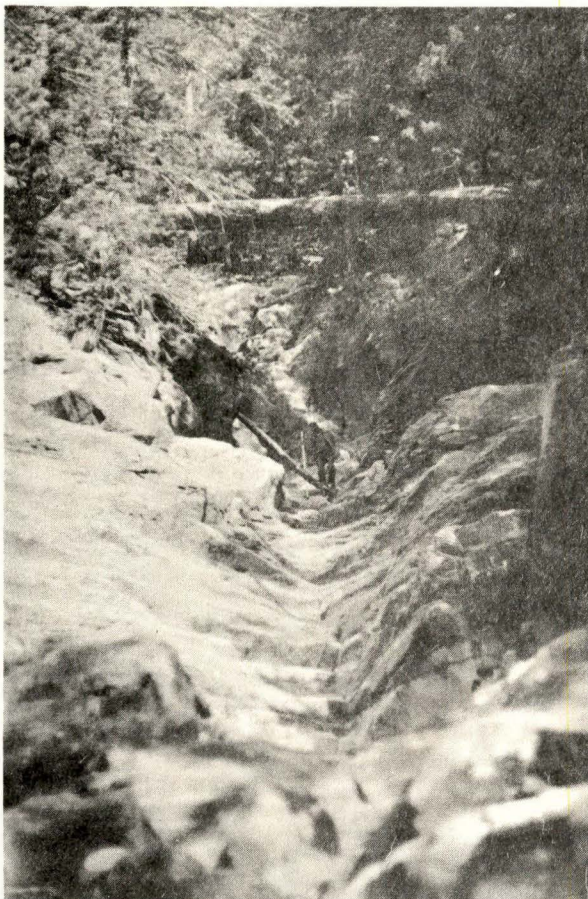
Photo 8 - Channel cutting just below the Rim consisted mostly of widening due to exposure or nearness of bedrock to the surface.

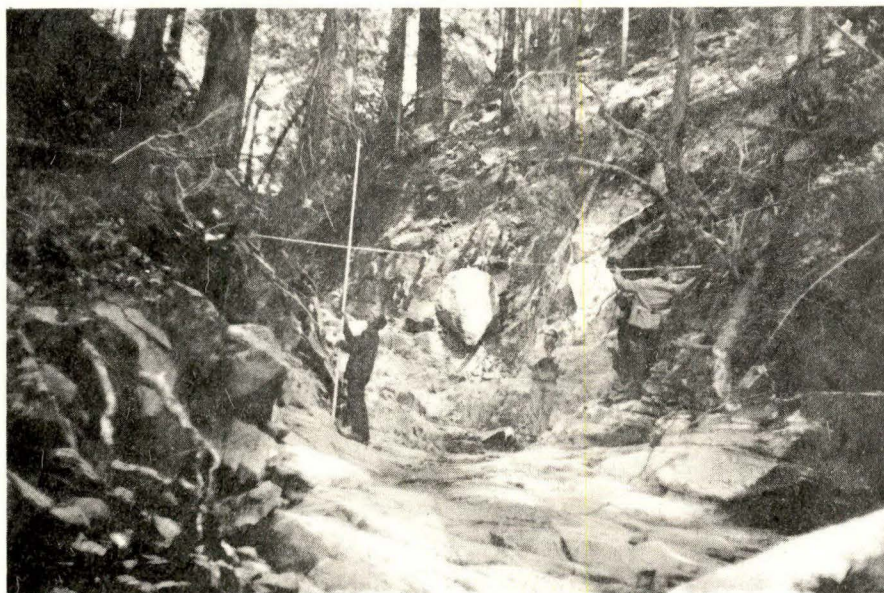
Photo 9 - Channel widening into colluvial slopes provided the source of large amounts of debris consisting of rocks, soil and undermined trees.

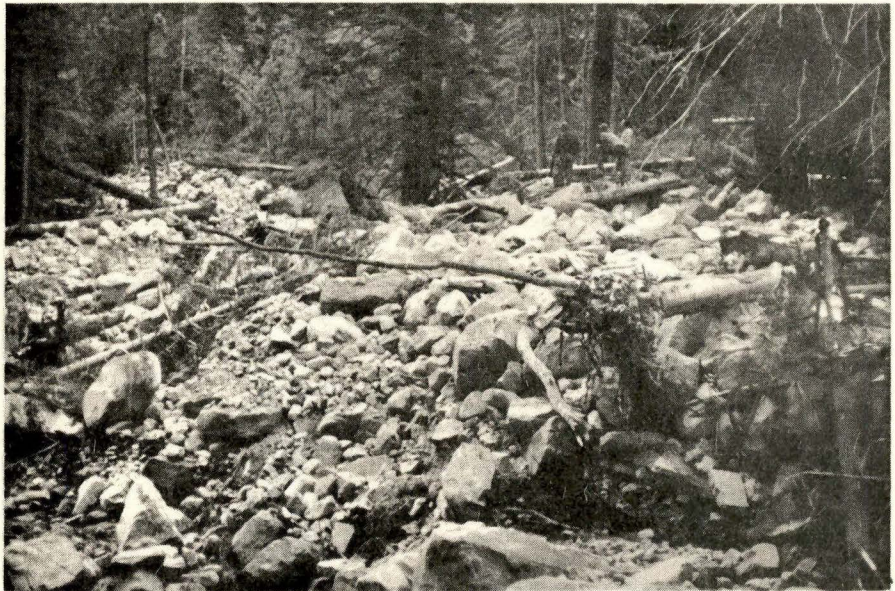
Photo 11 - As the channel gradients decreased at the bottom of the Rim, large boulder and debris piles were deposited.

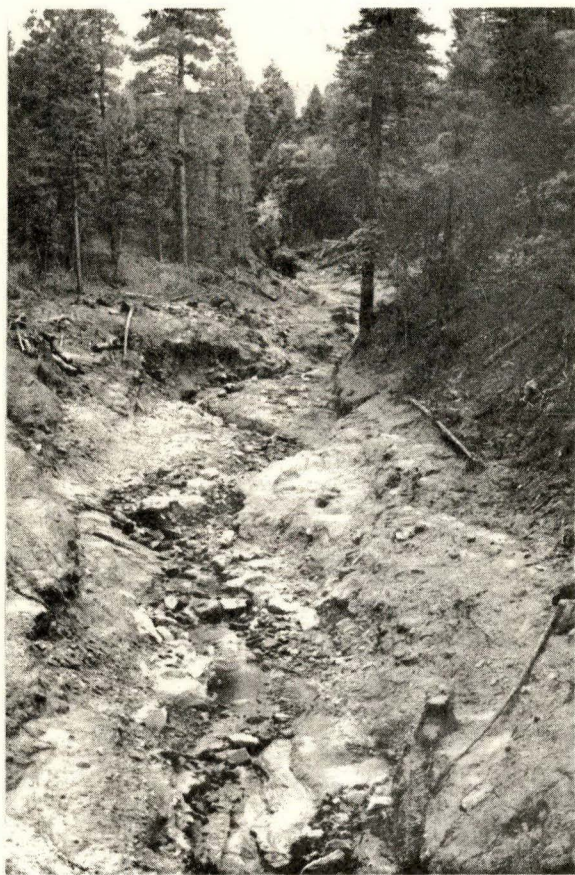
Photo 12 - Dick Williams
Creek is now a gutted
channel through its entire
length where prior to the
flood it was a "brook-like"
channel lined with trees,
shrubs and moss covered rocks.

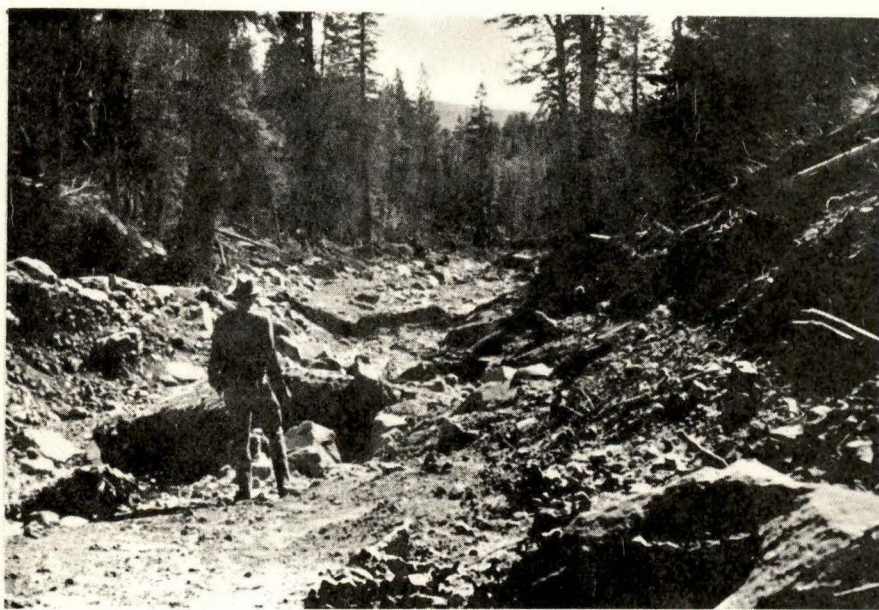
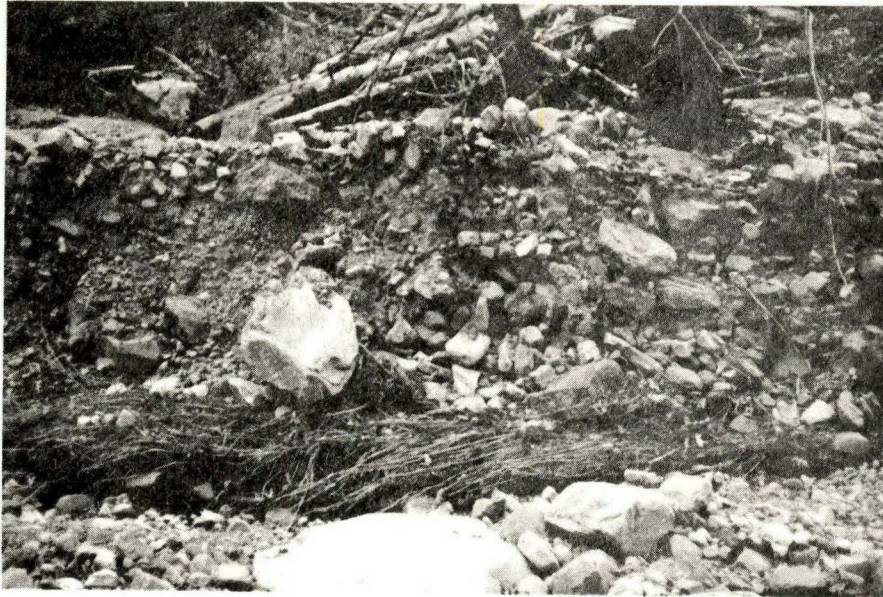
Photo 13 - Debris dams temporarily reduced the velocity of the floodwaters allowing alluvial deposits to build up. As the dams were breached cutting of the deposits began to occur again.

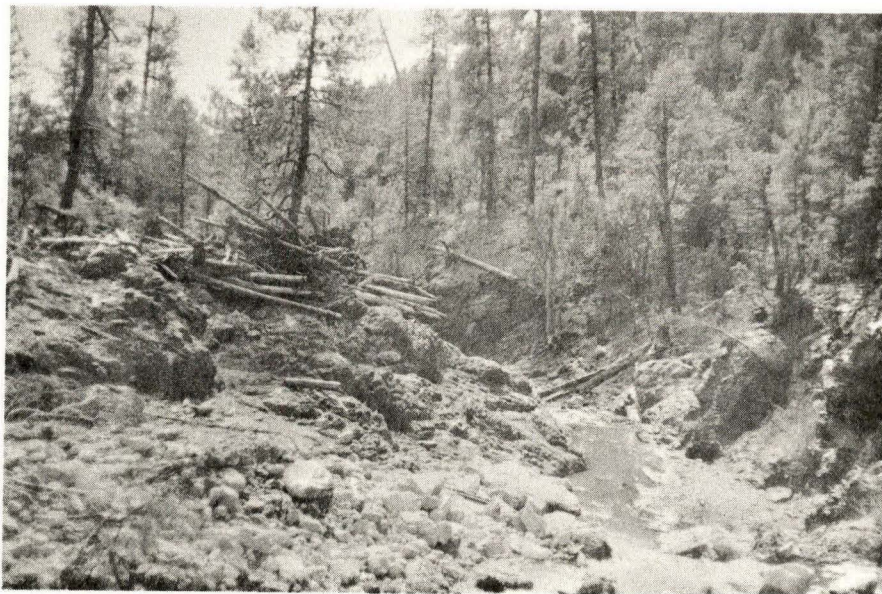
Photo 14 - Once the velocity of the flood waters increased after the debris dams broke, the channels were again scoured clean.

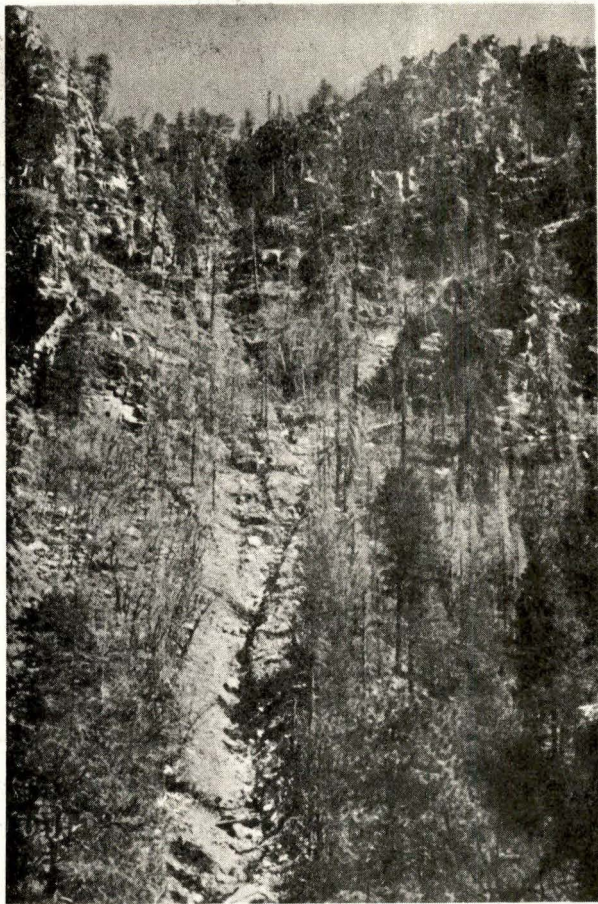
Photo 15 - The most southerly of three major debris flows occurring in Upper Dick Williams Creek. These mass movements extend from the stream channel to the base of the rock outcrops near top of Rim. Note man at point of marker.

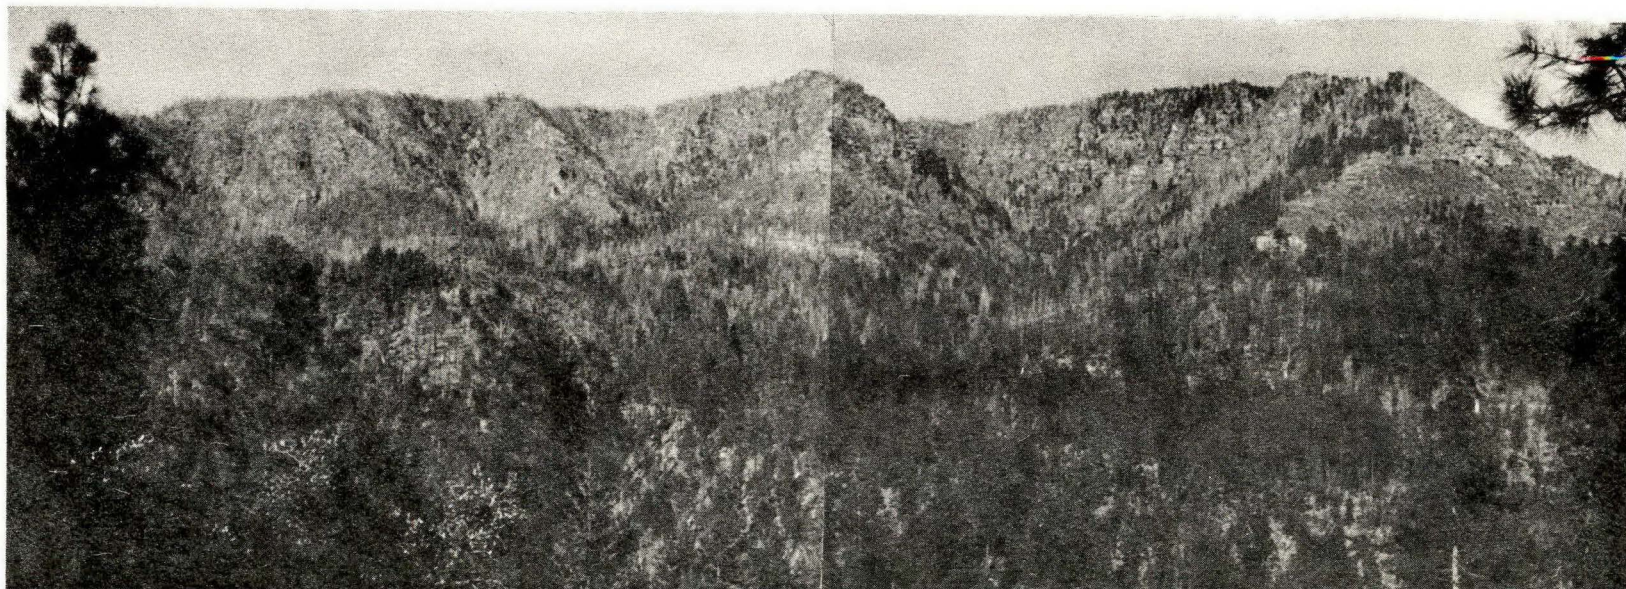
Phot0 16 - View of Mogollon Rim showing locations of Sample Watershed Nos. 23 and 24 and Dick Williams in relationship to 1968 and 1961 Hatchery Burns.

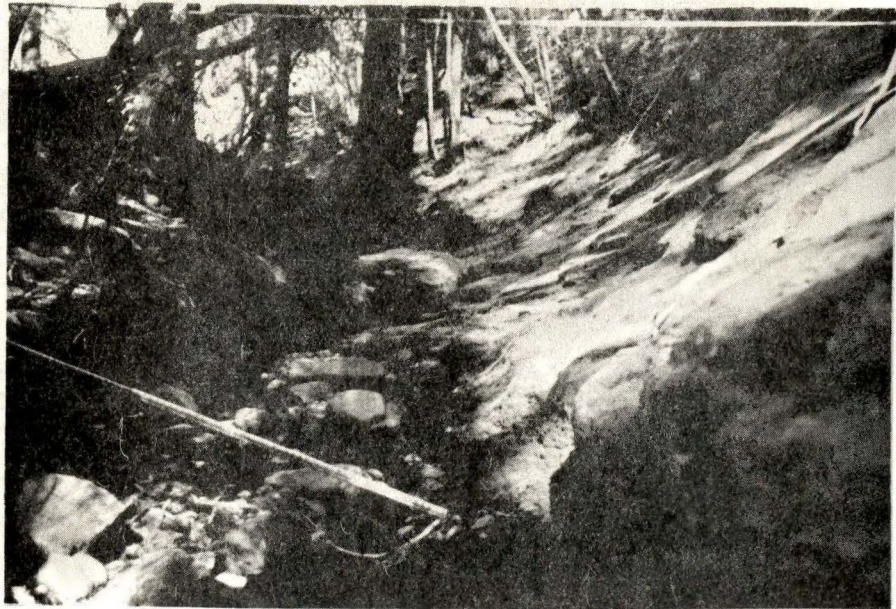
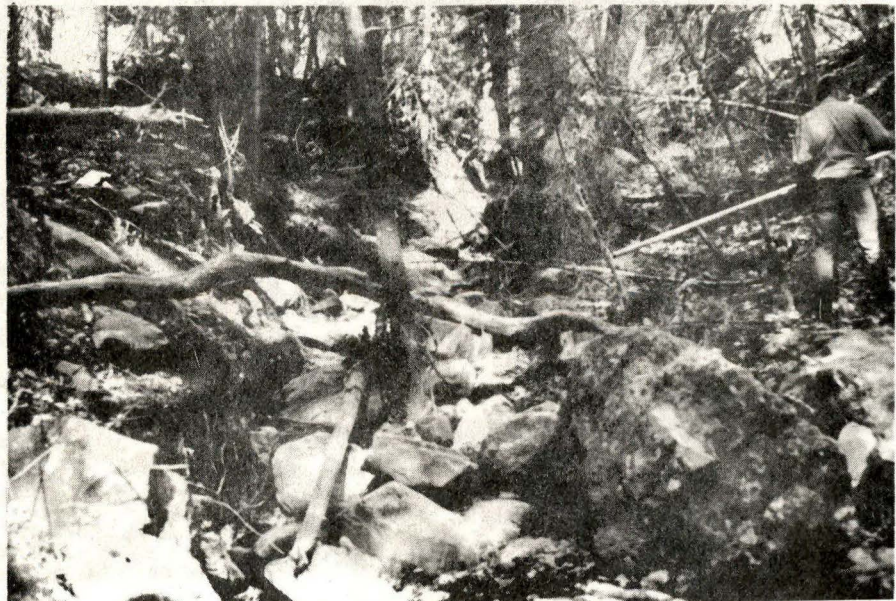
Photo 17 - Channels leading from Sample Watershed Nos. 23 and 24 were only slightly damaged as compared to Dick Williams, although they were similarly burned by the 1968 Hatchery Fire.

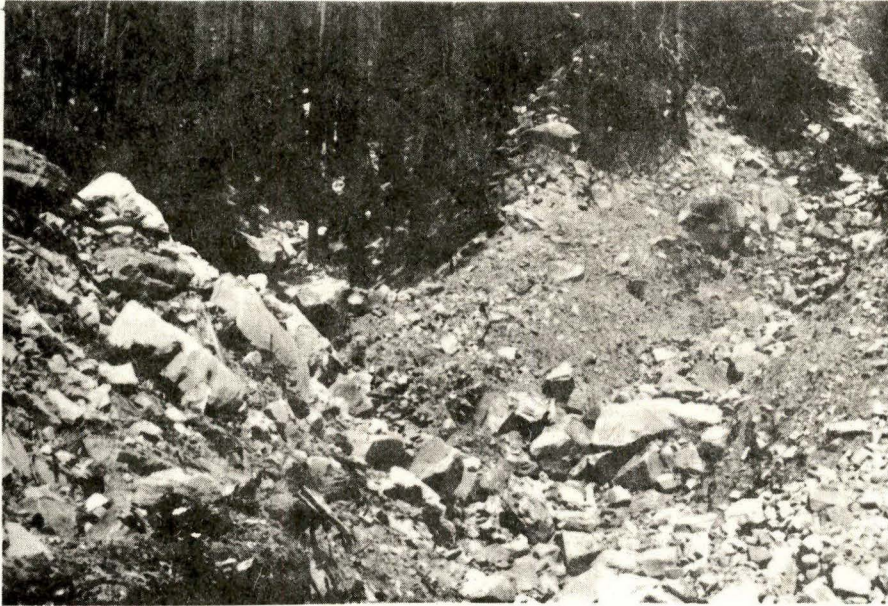
Severe channel damage begins where the most northerly of three major debris flows enters the channel. Note debris flow enters on the right leaving a large debris pile on the left. There are 68 acres in Dick Williams Creek above this point.

Photo 18 - Channel damage caused by debris flows in Upper Dick Williams Creek.

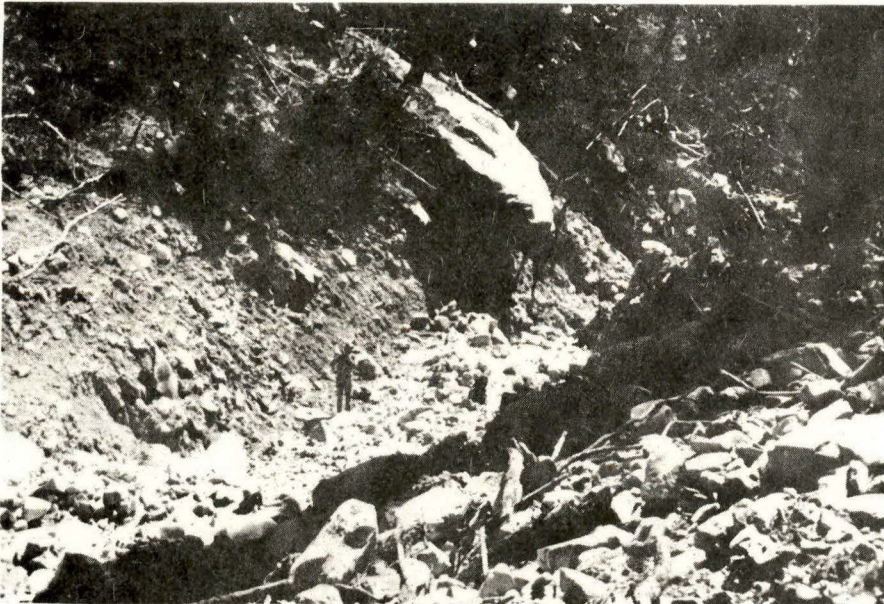
Looking downstream, the debris was deposited to a depth of 30 feet through which a channel was later cut.

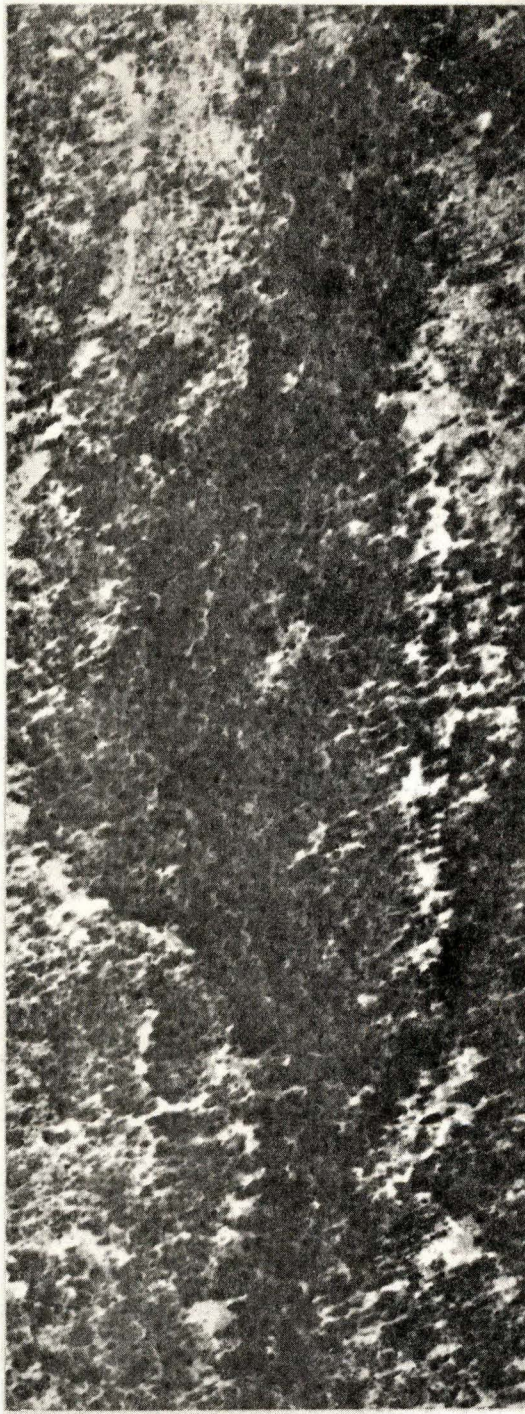
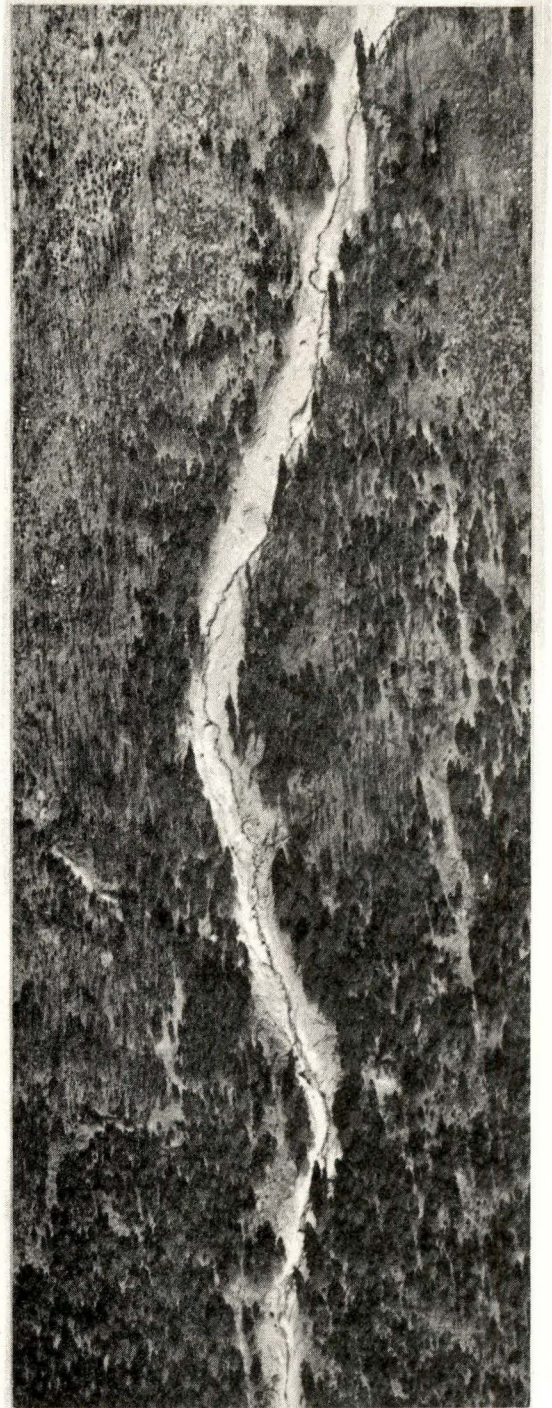
Figure - 21 Aerial view of stream channel damage in Upper Dick Williams Creek before and after September 5, 1970 flood.

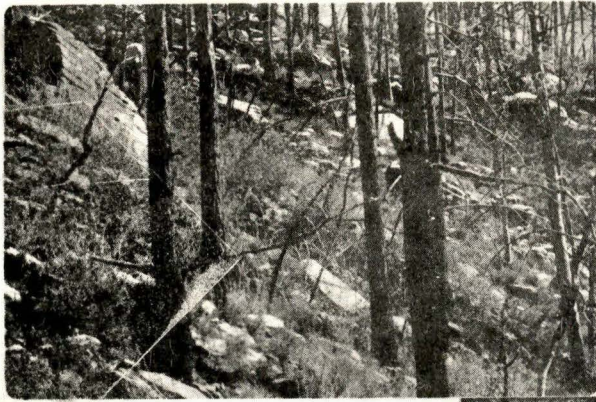
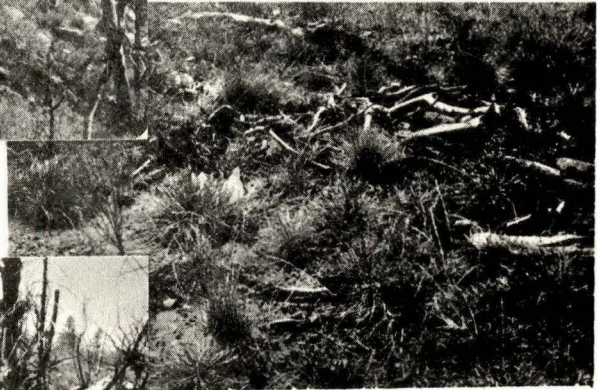
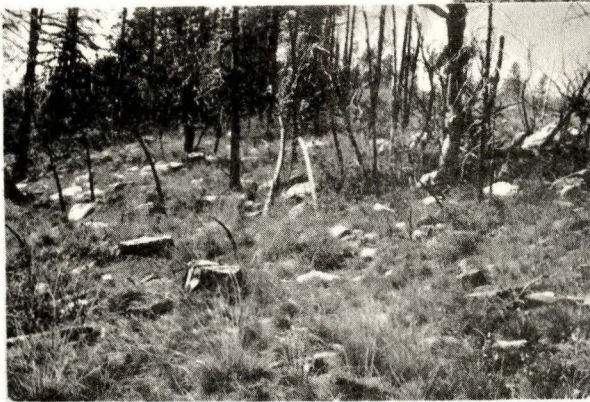
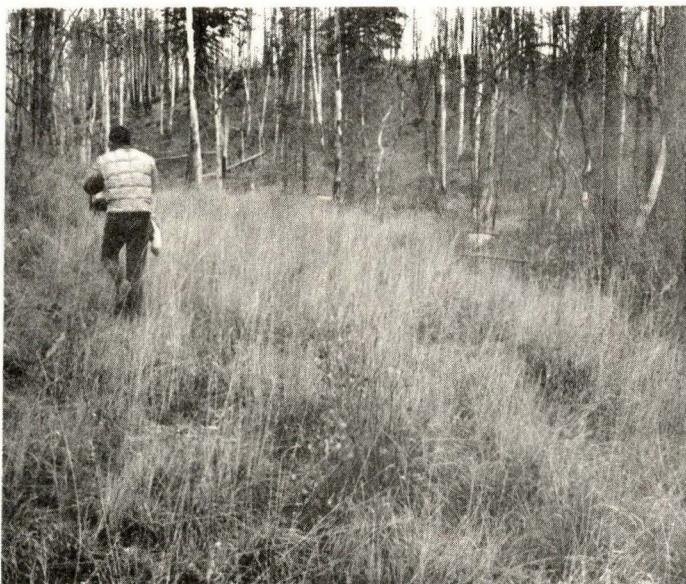
Photo 19 - Seeded grasses on upper slopes of 1968 Hatchery Burn provide good ground cover protection.

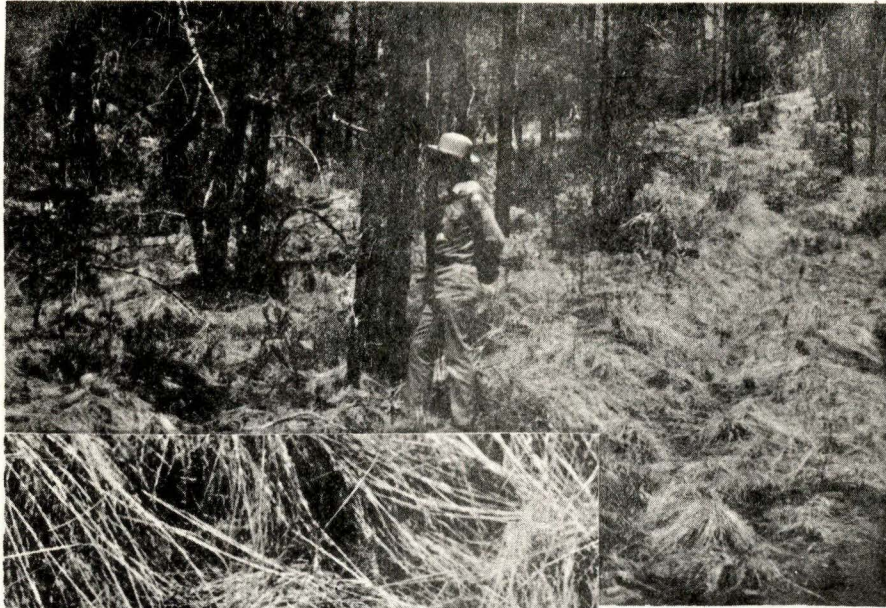
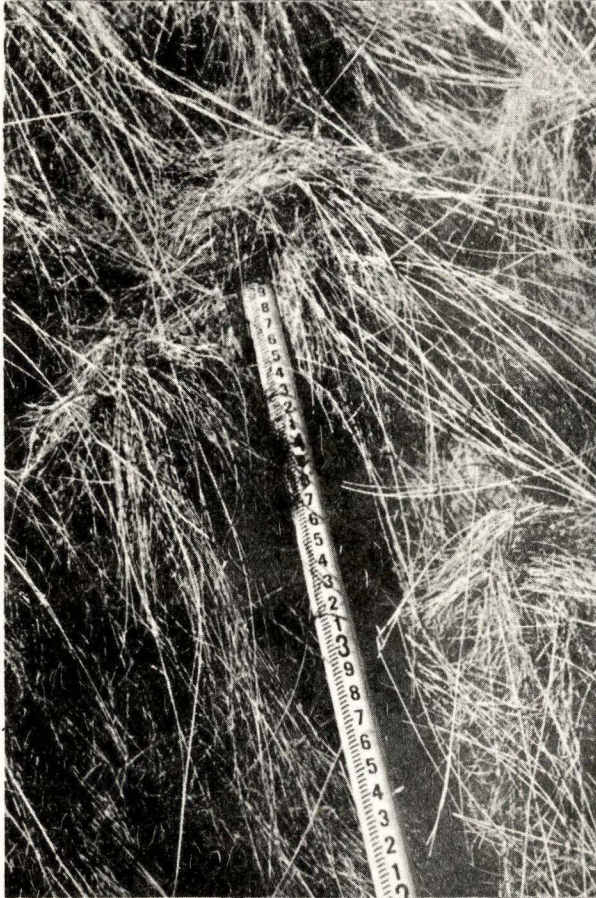
**Photo 20 - Good ground
cover is provided by
lovegrass seeded on
lower slopes of 1968
Hatchery Burn.**

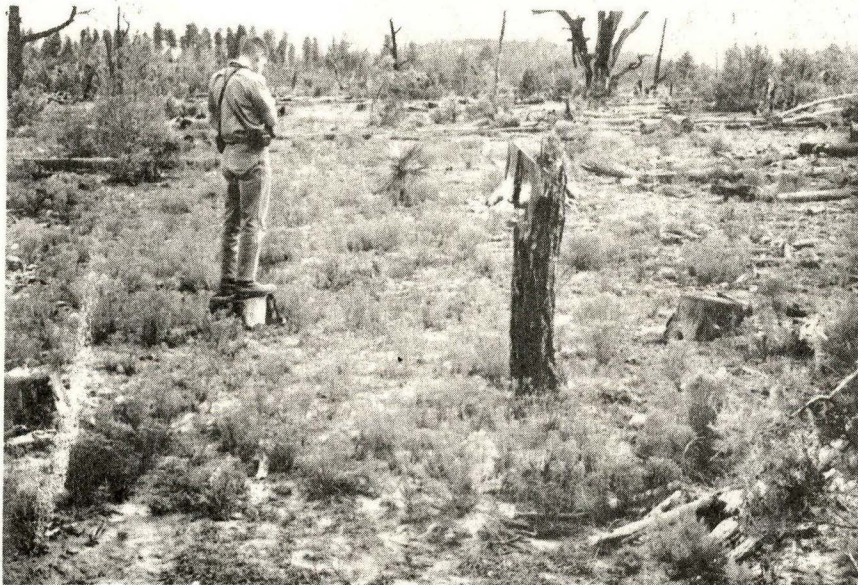
Photo 21 - The Roberts Burn with its soils of low infiltration capacity and sparse ground cover was a high storm runoff producing area. However, its moderate slopes and low channel gradients prevented this area from developing severe channel damage.

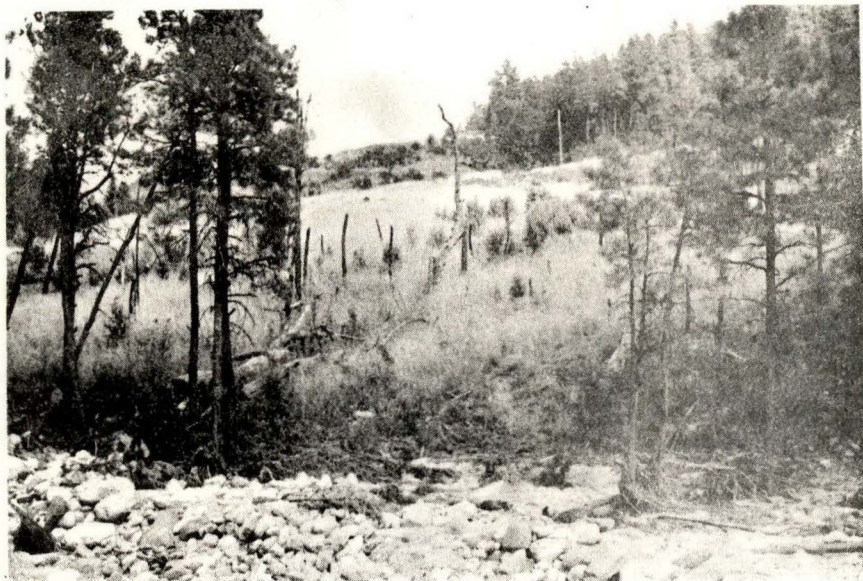
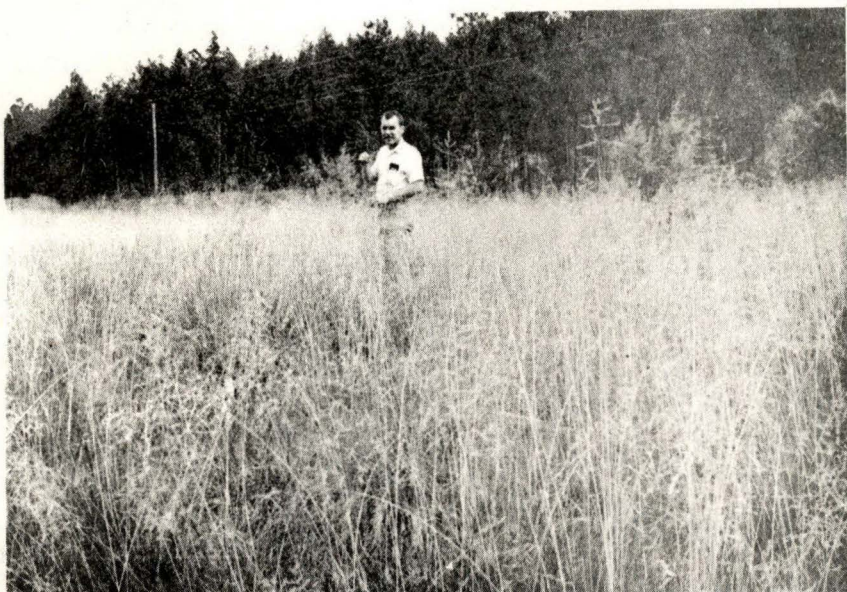
Photo 22 - Seeded lovegrass in powerline right-of-way demonstrates the ability of seeded grasses to provide excellent ground cover protection.
